# Elma Turner Library

## Detailed Seismic Assessment

Prepared for Nelson City Council

Prepared by Beca Limited

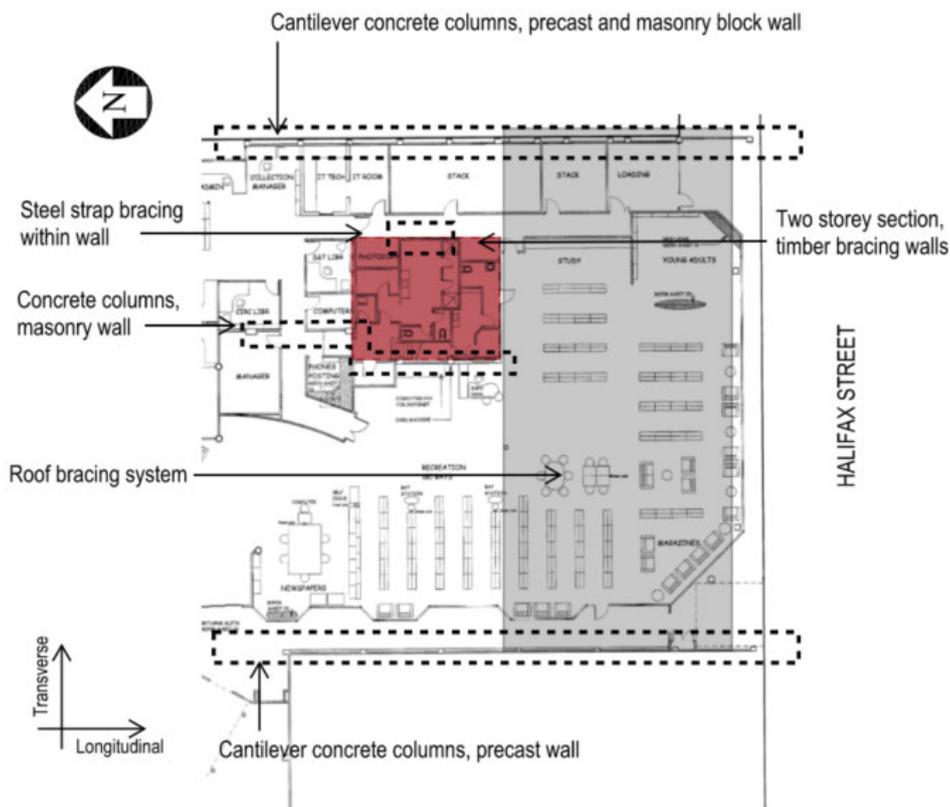
Figure 2.4: Close up of South section of the building indicating the lateral load resisting systems.

Seismic loads from the main building are resisted by walls along the eastern and western boundary wall and the internal wall line identified in Figure 2.4. The eastern boundary wall is a combination of precast panels, concrete frame with masonry block infills and masonry block walls. It was constructed in 1956 and 1961 and then strengthened in 1985 and 1989. Refer to Figure 2.7 for details. The western boundary wall is a precast panel wall connected to the concrete columns. The internal wall is assumed to be a reinforced concrete frame with masonry infills (few details are available for this wall).

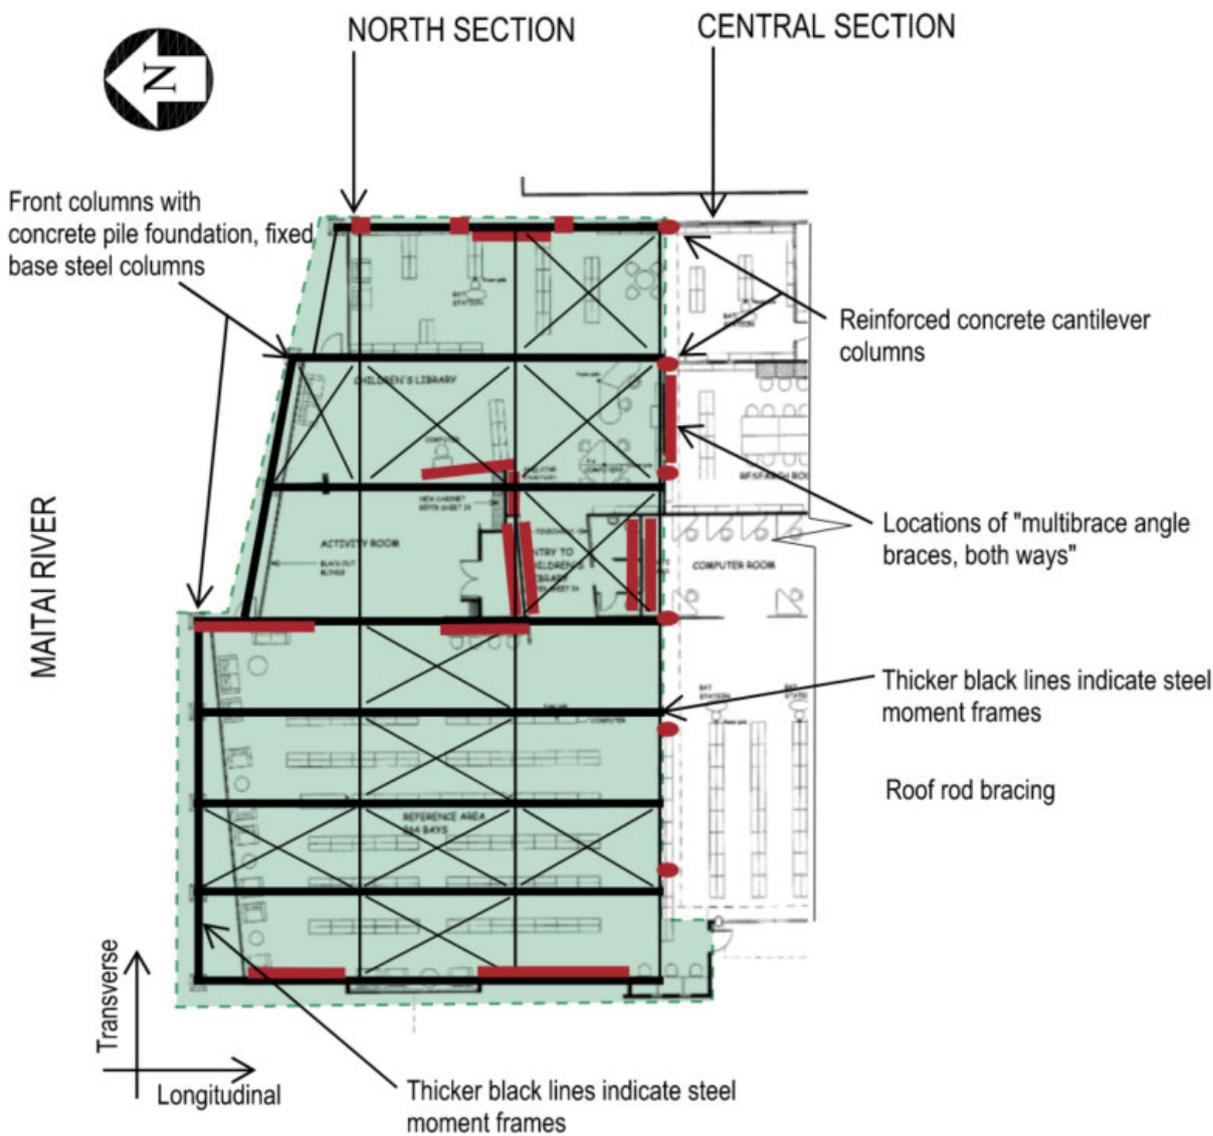
Figure 2.5: Key structural features of the north section of the building.

- Slab on grade.
- Shallow pad footings beneath gravity posts.
- 600mm dia. x 3m deep concrete piles under columns along Maitai river.
- Reinforced concrete ground beams to support cantilever columns along western boundary, and central section boundary.
- Foundations are generally not tied together.

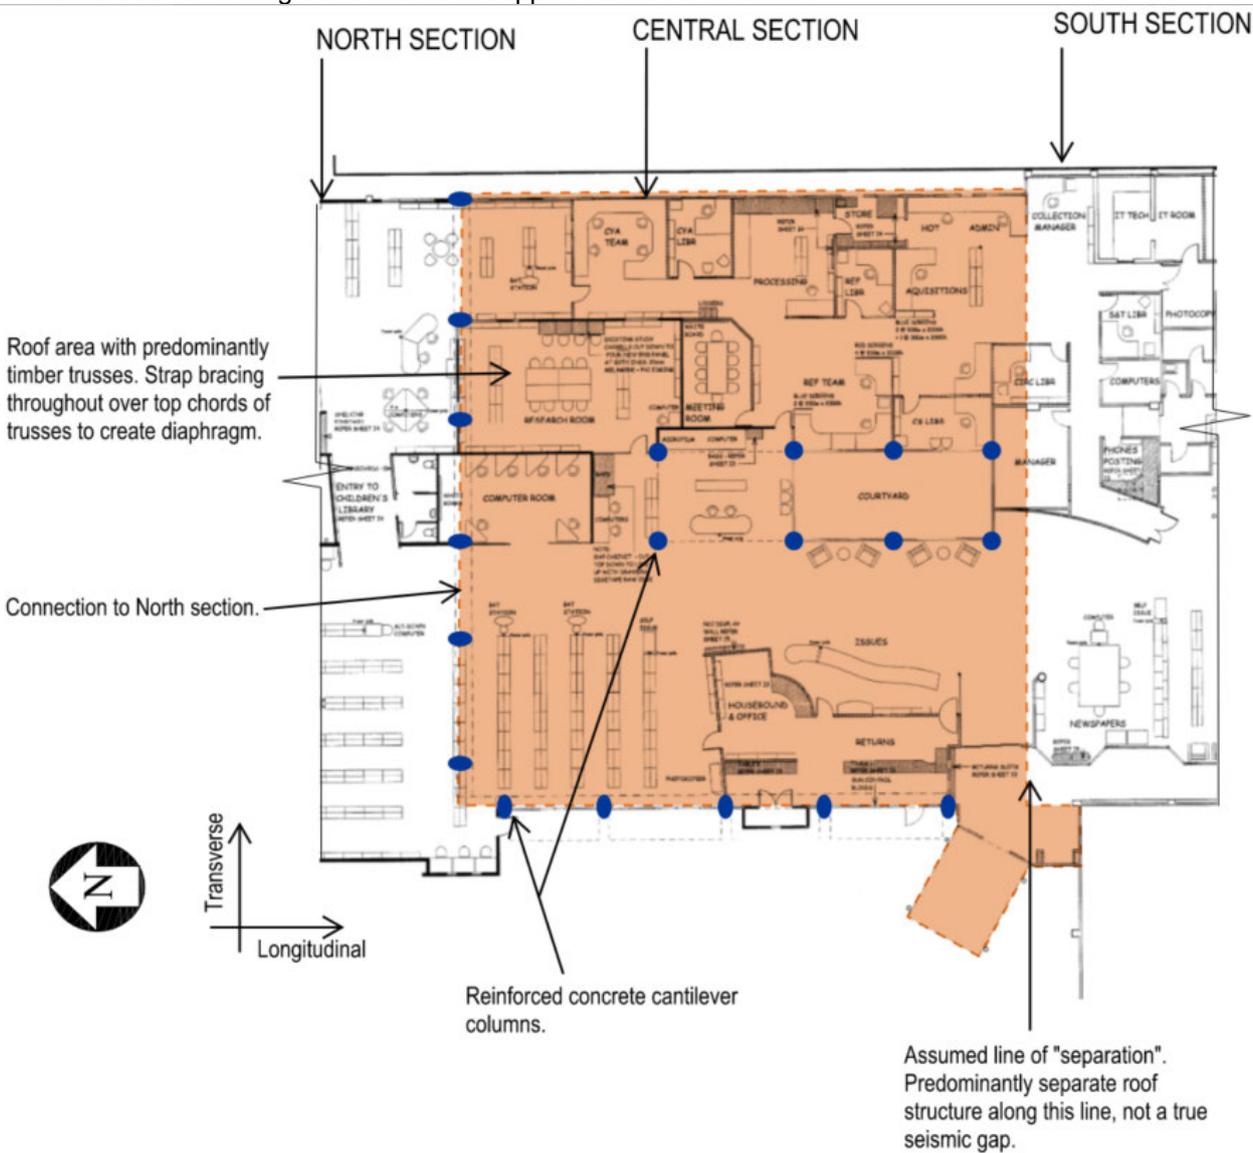
Figure 2.6: Key structural features of the central section of the building.

- Slab on grade.
- Reinforced concrete ground beams to support cantilever columns.
